APPENDIX A  
GEOTECHNICAL REPORT -- RENSSELAER TECHNOLOGY  
PARK CONNECTOR ROADWAY

October 14, 1988

Re: The letter of August 29, 1988 from Michael Wacholder  
regarding additional recommendations desired by  
Daniel Schuster of Schuster Associates - File No. 3318

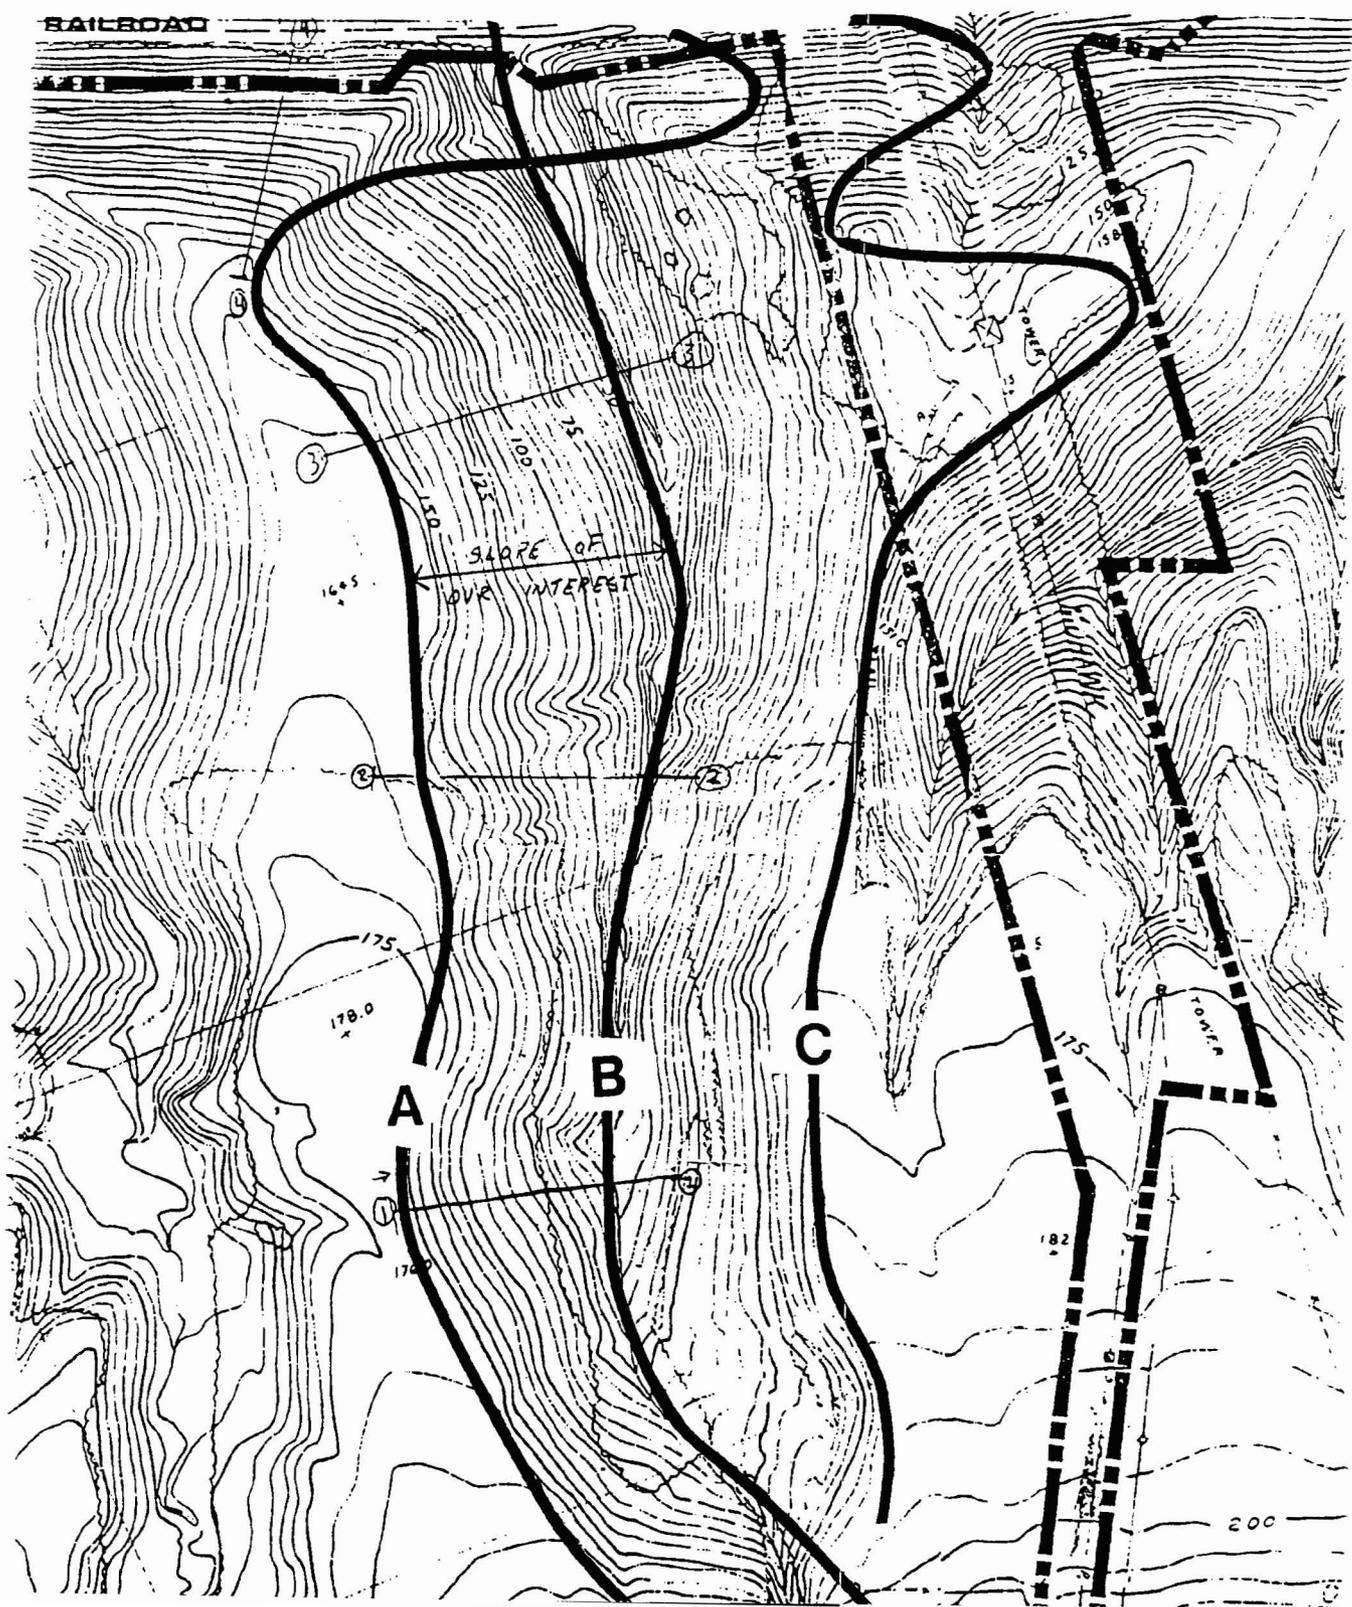
These profiles analyzed are shown in Figure 1 in the plan. Additionally, analyses of altered sections were performed. These were the same profiles as cross sections with about 10 feet of cut removed at the top of the slope and about 15 feet added as fill at the toe of slope. In those altered cross sections the stability was re-examined using historically high water table information gained from analyzing the existing natural profiles. The effect on the safety factor and stability of the slope with material removed from the top; added to the bottom; or, with improved drainage near the toe of the slope has been determined for the assumed conditions.
