SECTION II - INVENTORY AND ANALYSIS

PREPARATION OF A LOCAL WATERFRONT INVENTORY

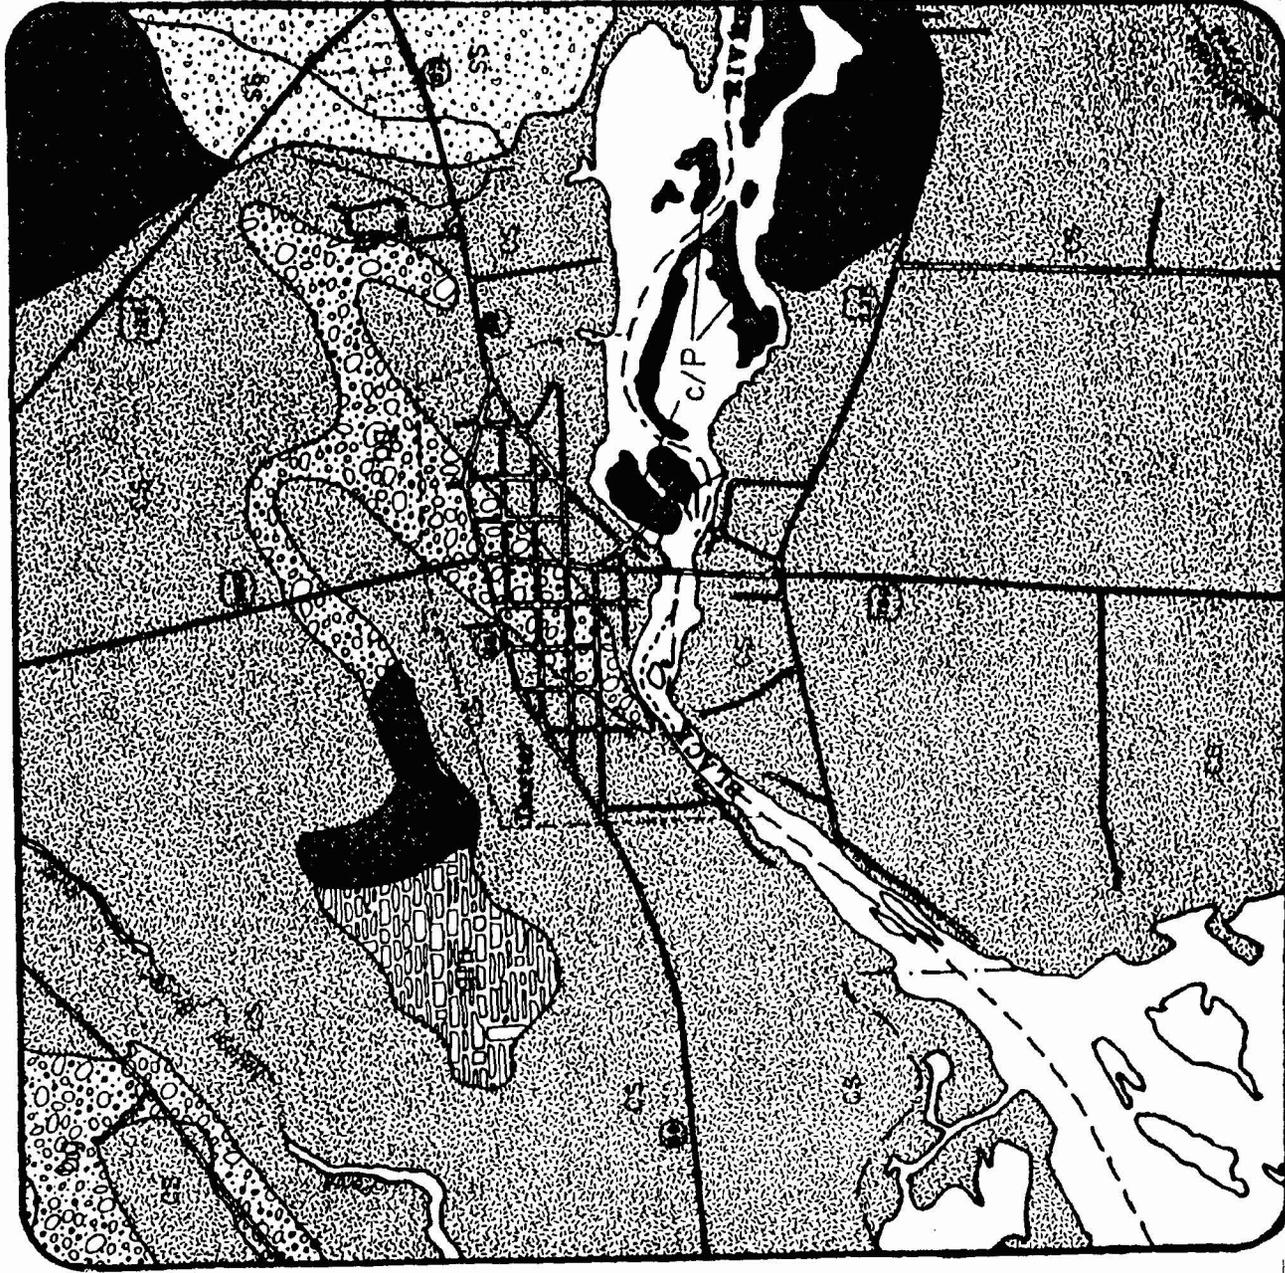
SURFICIAL GEOLOGY

Surficial geologic deposits underlying the village are representative of those resulting from post-glacial lake and meltwater activities. Most common in the waterfront area are silts, clays, beach gravel, gravel wash and sea sands. These deposits are mapped on Plate V.

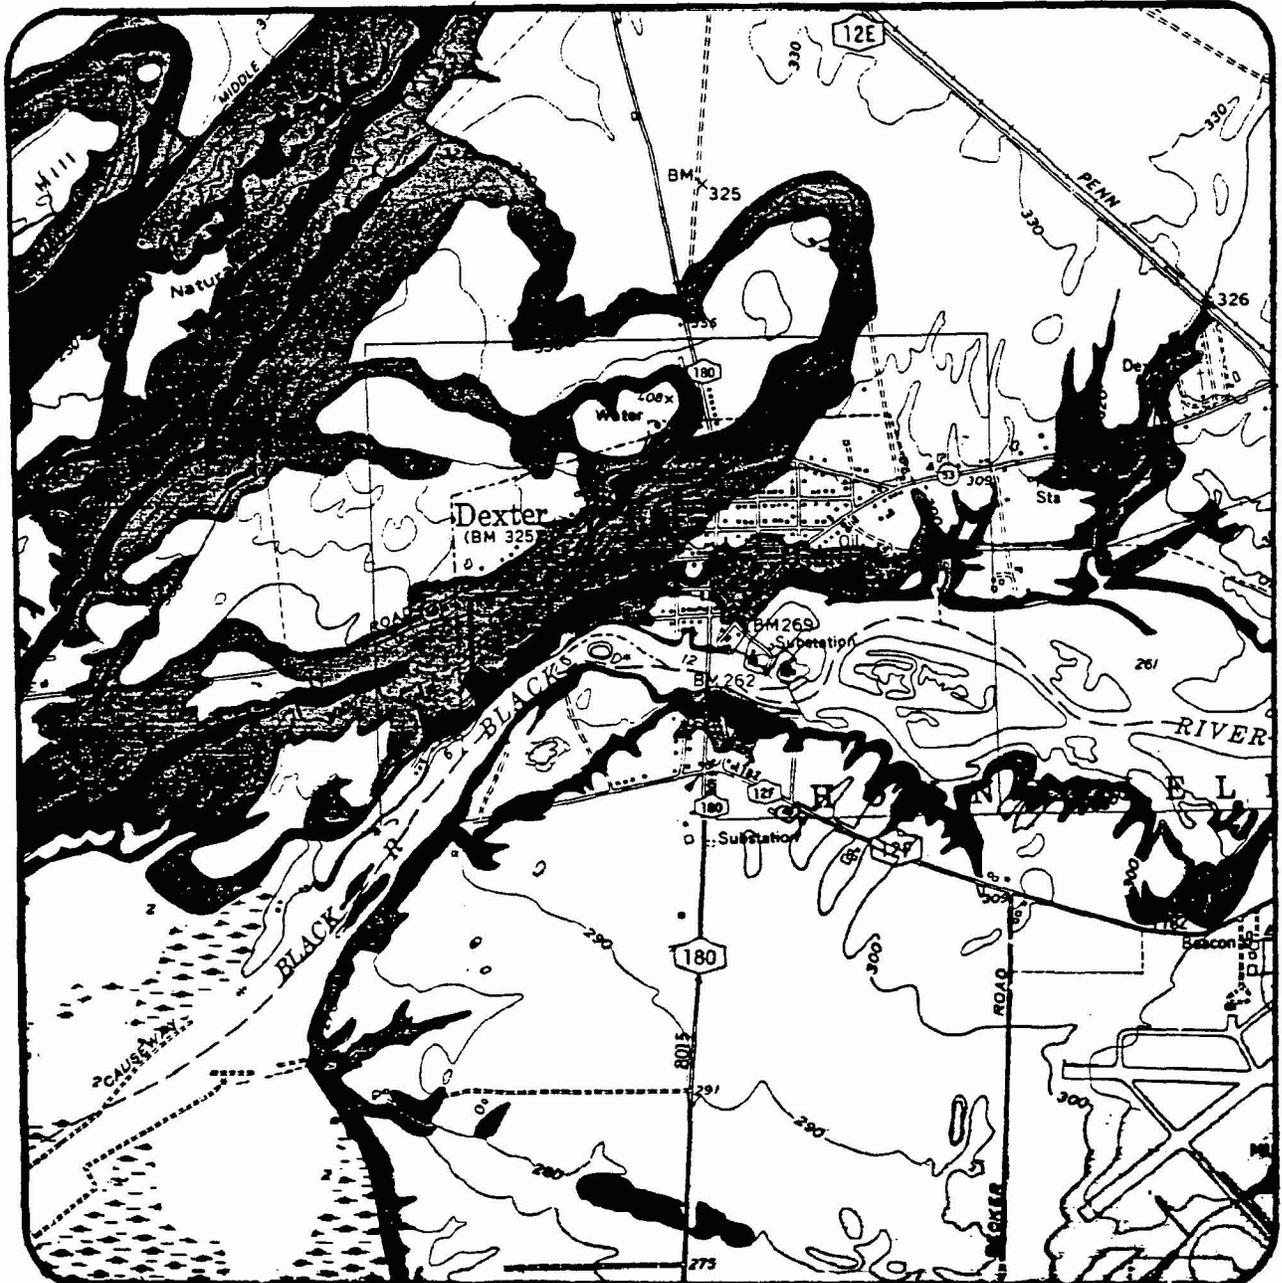
TOPOGRAPHY

The topography of the waterfront rises from east to west along the Black River. A dramatic variation in terrain is exhibited to the west of the former Sulphite Mill where slopes exceed 15%. The remaining waterfront areas have slopes generally less than 8%. Slopes for the entire area are illustrated on Plate VI.

(D)- Slope (see Plate VI). Topography limits development in that portion of the waterfront generally to the west of the former Sulphite Mill where slopes exceed 15%. Proper design and care in siting development in this area will be critical in avoiding adverse environmental impacts. Improper development on the area's steep slopes could result in increased erosion, slumping and general soil instability which would cause increased siltation, foundation problems and difficulties with the use of individual septic systems.

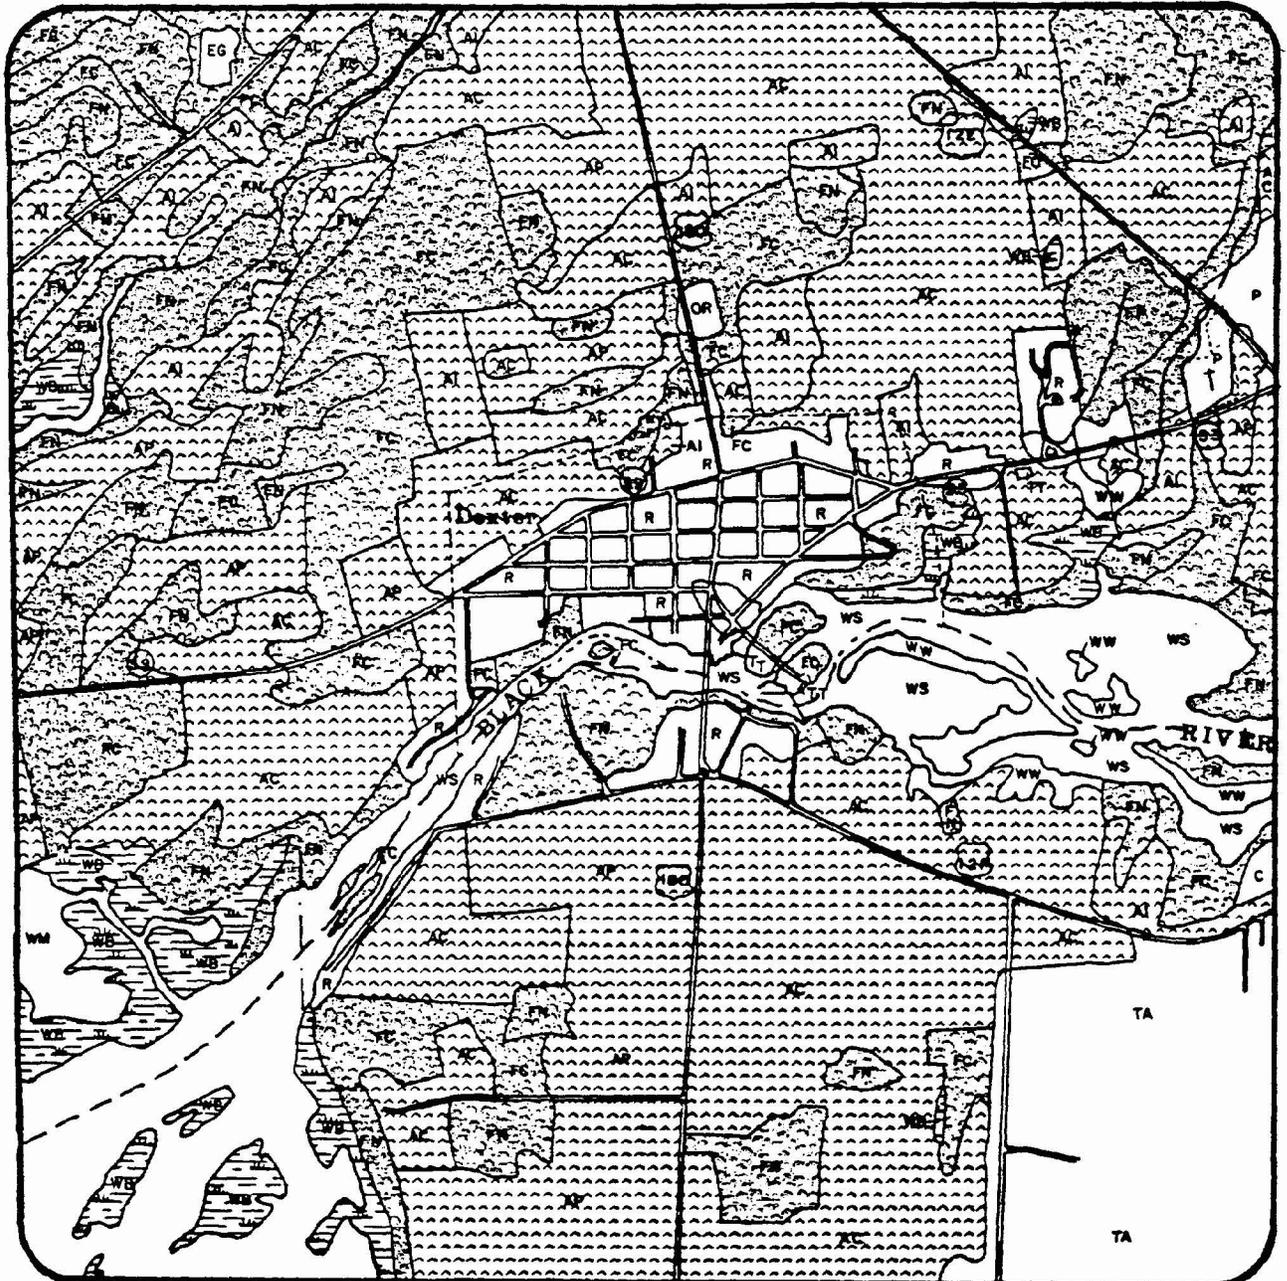
VEGETATION*

Vegetation located west of the former Sulphite Mill and on portions of Fish Islands is limited to forest and forest brushland types. Downstream, the extensive 1,200 acre wetlands complex at the east end of the Black River Bay is characterized by a variety of species of wetland vegetation, shrubs and pockets of wooded areas. Vegetation found in the Dexter waterfront is generally illustrated on Plate VIII.

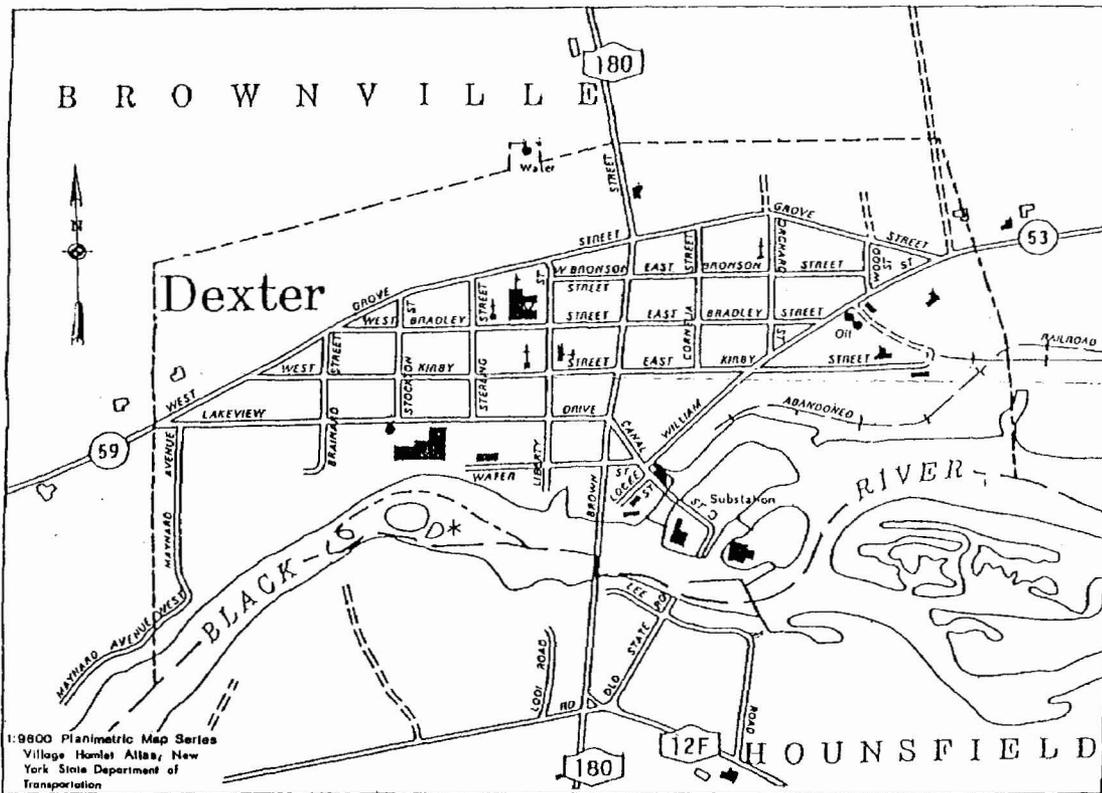
Transportation Network

The transportation system serving the Village of Dexter includes a network of local, county, state and interstate roads and an international airport. Plate X illustrates this transportation network. Regional transportation serving the area includes Interstate 81 (seven miles to the east), the Watertown International Airport (one mile to the east) and rail services in Watertown (ten miles to the east).

NY Route 180 is the only major highway passing through the village. It provides a direct linkage to NY Routes 12E and 3 (south of the village) and to NY Routes 12E and 12 (north of the village). County Routes 53 and 59 serve as local collector roads and provide access to the Village of Brownville and Pillar Point. The remaining streets in the village carry relatively low volumes of local traffic.

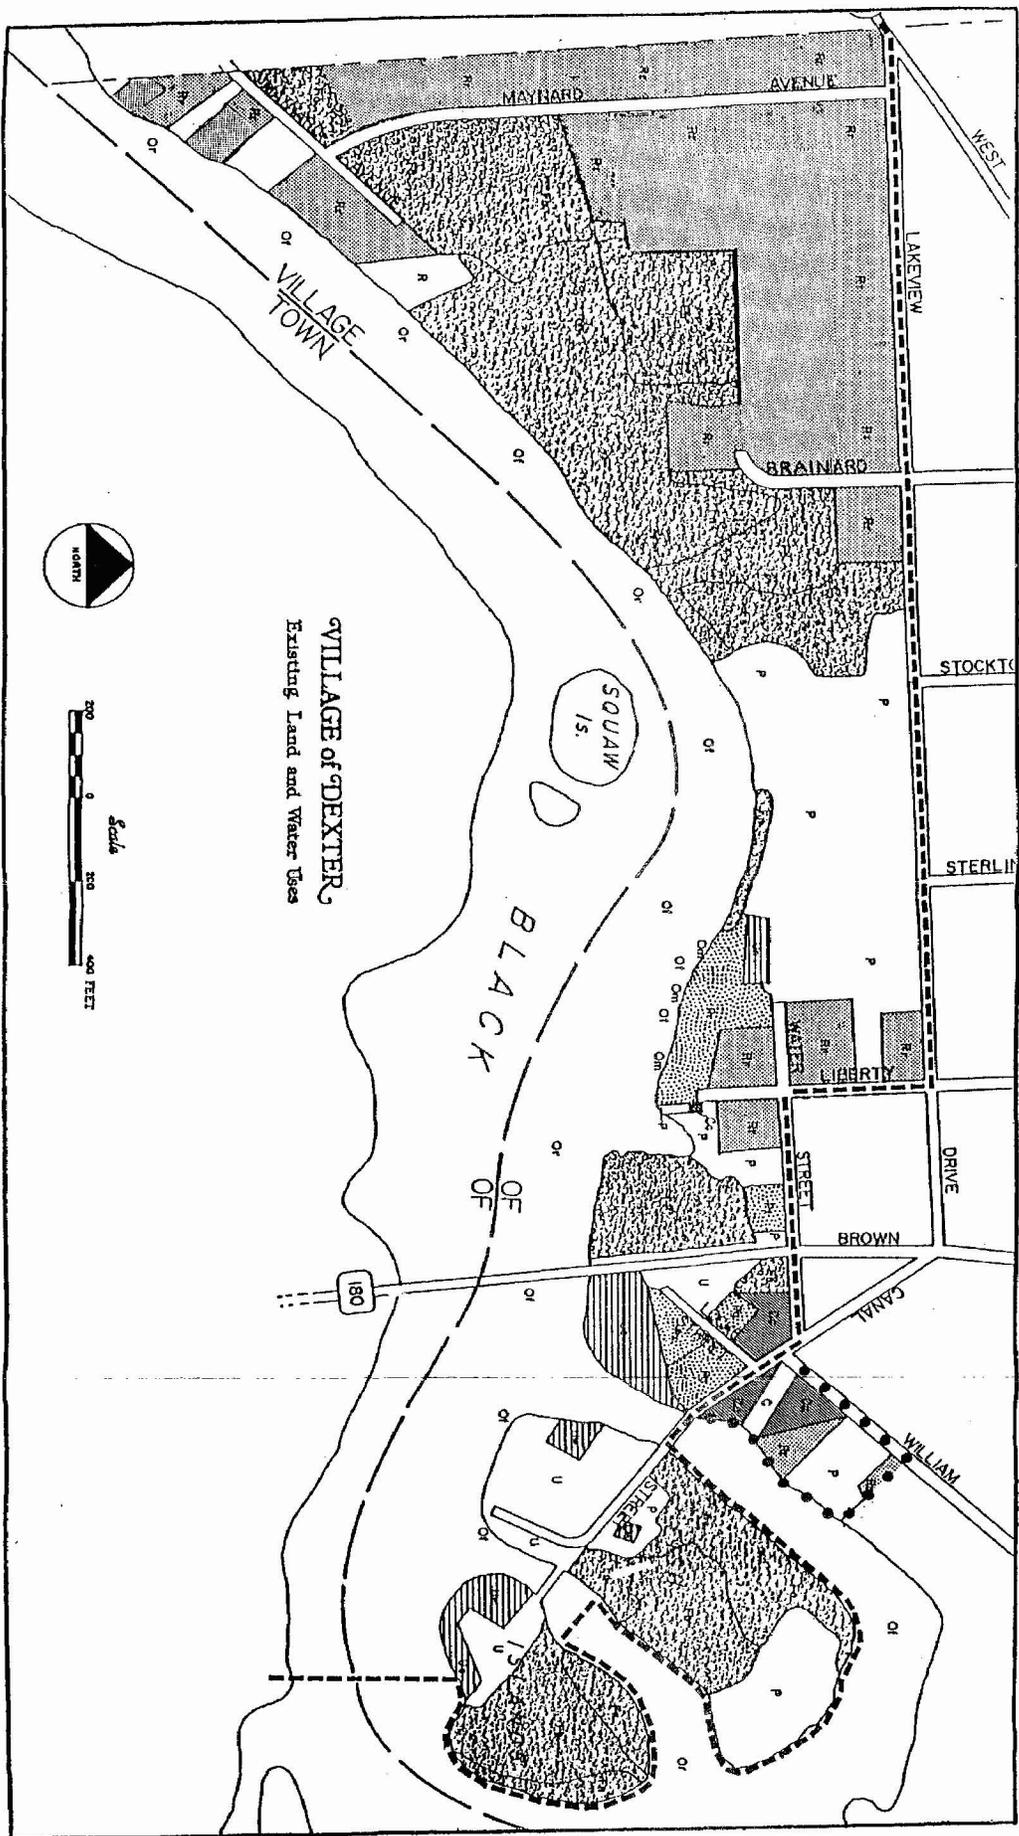
VILLAGE of DEXTER,
Existing Land and Water Uses

Current Land and Water Uses. Analysis of the Dexter waterfront area indicated five principal categories of land use: residential, commercial, transportation/utilities/communications, public/semi-public and vacant. Plate XI entitled "Village of Dexter - Existing Land and Water Uses," shows their extent and distribution.

3) Transportation/Utilities/Communications. Plate XI shows, in addition to the principal streets serving the waterfront, two important land uses in the "utilities" category. The first, involving facilities for production of hydroelectric power, the Hydro Development Group Incorporated, occupies the southernmost portions of the village core and the largest Fish Island, the entire smaller island and, includes the three dams spanning the Black River. Sewage treatment facilities for the village are the second. These are found on the south side of Water Street adjacent to the boat launch parking area.

5) Vacant. Comprising more than one-half of Dexter's waterfront, vacant land is by far the most prevalent category. Plate XI illustrates the extent of vacant land, including areas classified as forest or forest brushland. Pulp and paper mills once occupied extensive areas in Dexter along the Black River. Abandonment and demolition of most of the mills since the middle of this century has resulted in vast areas of vacant, deteriorated waterfront coming under village ownership or, in certain cases, being acquired by adjoining residential land owners.
